FILE NO: BD 361  
of 2008

**RE: Existing dwelling – 9 Gilmore Street, Tarragindi**

BE:SR:08/6978

BE:SR:08/6978A

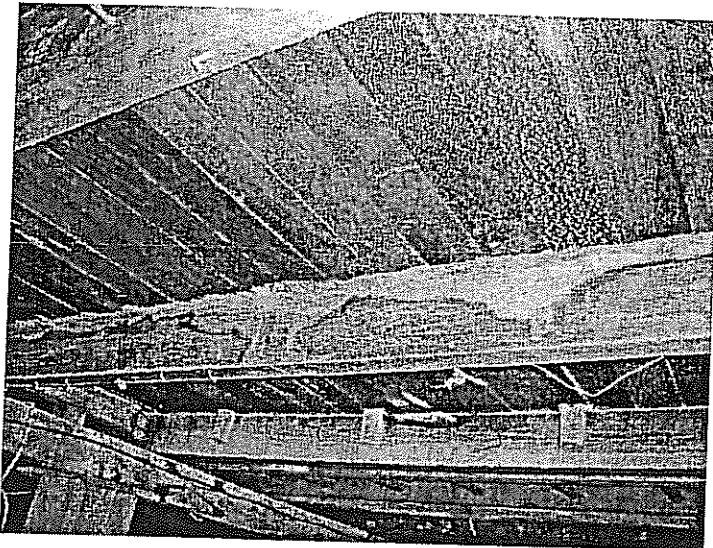
- As is typical for this type of dwelling, upgrades to bracing and tie down conditions are likely to be required around the building as renovations are carried out.
- Signs of previous pest (termite) activity was noted to the floor framing.

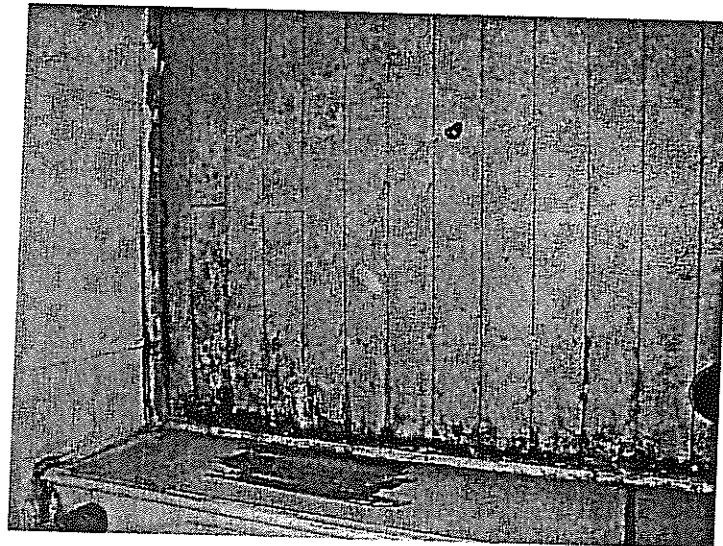
- Timber rot was also noted to floor framing around the building and to staircases.

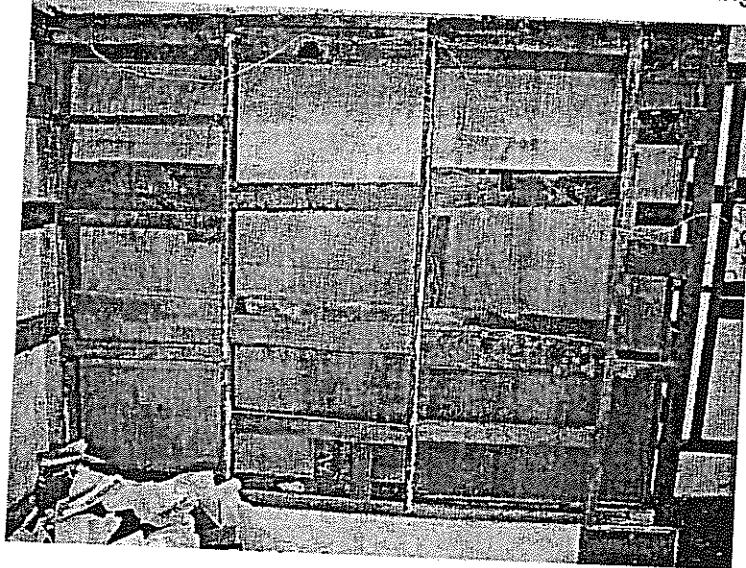
- There is a small masonry retaining wall (approx 500 high) to the left hand side of the dwelling. The wall is built within the zone of influence of the stumps to the rear left hand corner of the property and is out of plumb. This wall has failed and will need to be replaced.
- At the time of our inspection, parts of the internal wall and ceiling linings had been removed to expose the internal stud wall framing. The wall framing appears to be constructed in an ad hoc fashion with uneven stud spacing and the use of odd timbers as nogging. Tie down and bracing was not in accordance with good building practice and will need to be completely upgraded around the building.
